**PRELIMINARY ASSESSMENT/
VISUAL SITE INSPECTION**

**PFAUTER MAAG CUTTING TOOLS
LOVES PARK, ILLINOIS
ILD 070 168 968**

FINAL REPORT

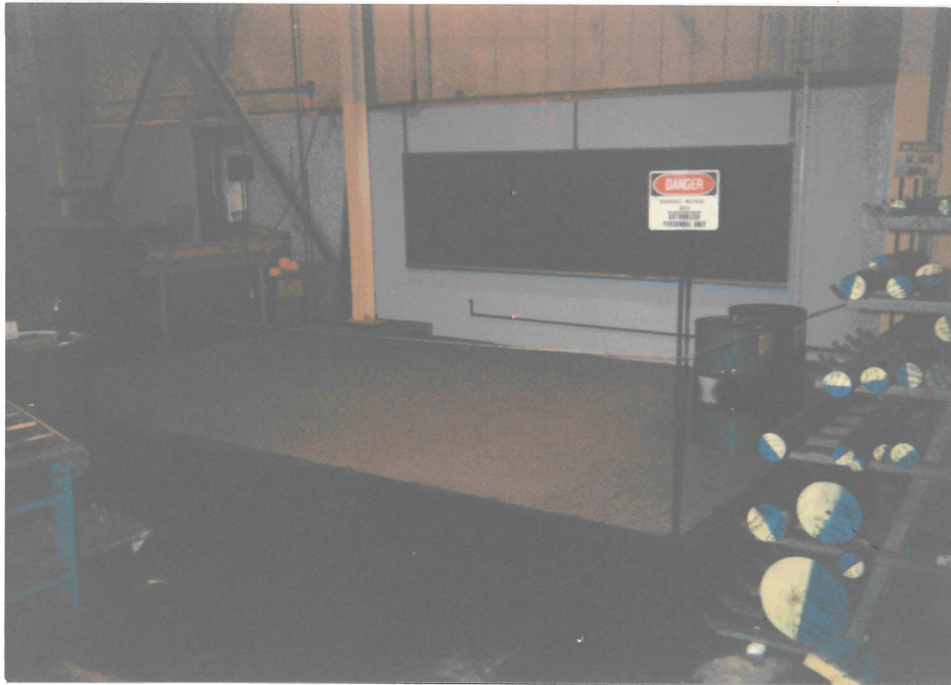
Photograph No. 1

During the VSI, the unit contained two sealed 55-gallon steel drums of waste Stoddard solvent (D001) and one 55-gallon steel drum of waste barium chloride (D005). There was no evidence of cracking, pitting, or staining on the concrete (see Photograph No. 1).

Description: This photograph shows the Hazardous Waste Storage Area. The blackboard in the background is used to track inventory.

Recommendations: PRC recommends no further action for this unit.

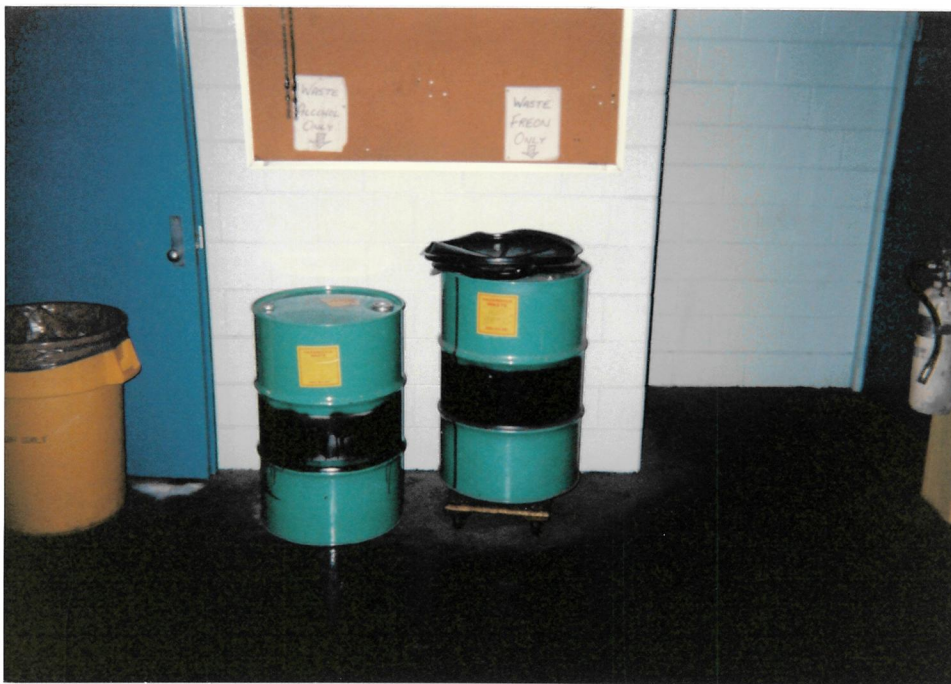
Photograph No. 2

Observations: During the VSI, drums used to accumulate the waste were sealed and there were no visible leaks, cracks, or evidence of spills. There was no cracking, pitting, or staining of the concrete (see Photographs No. 2 and 3).

Description: This photograph shows the Hazardous Waste Satellite Accumulation Area used to accumulate waste isopropanol and waste freon. Full drums are transferred to SWMU 1.

Recommendations: PRC recommends no further action for this unit at this time.

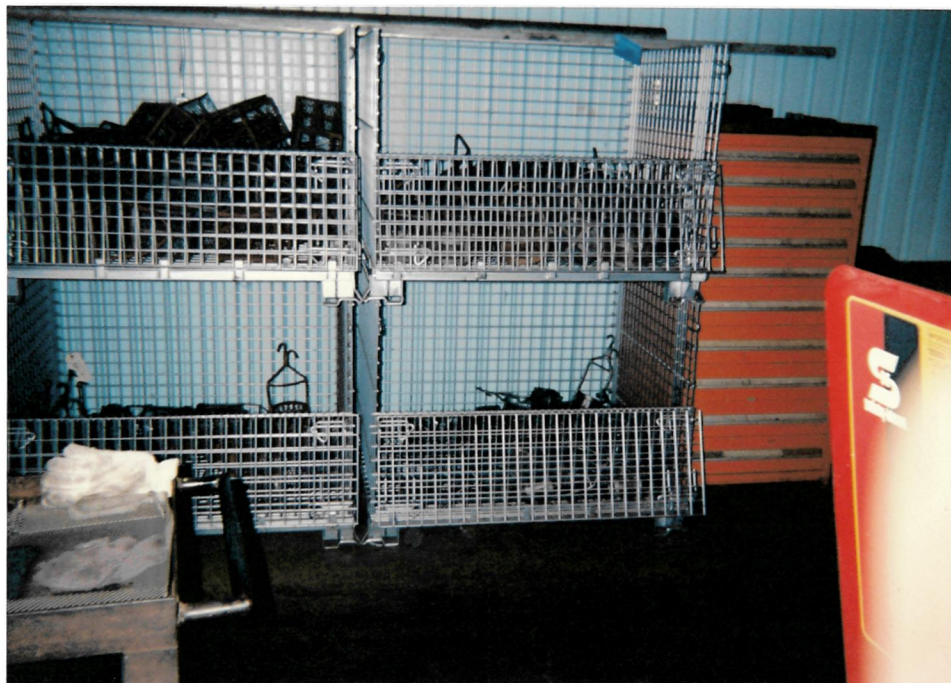
Photograph No. 4

Description: This photograph shows the Former Hazardous Waste Storage Area. The area was formerly used to manage waste barium chloride and waste cyanide salts.

Recommendations: PRC recommends no further action for this unit at this time.

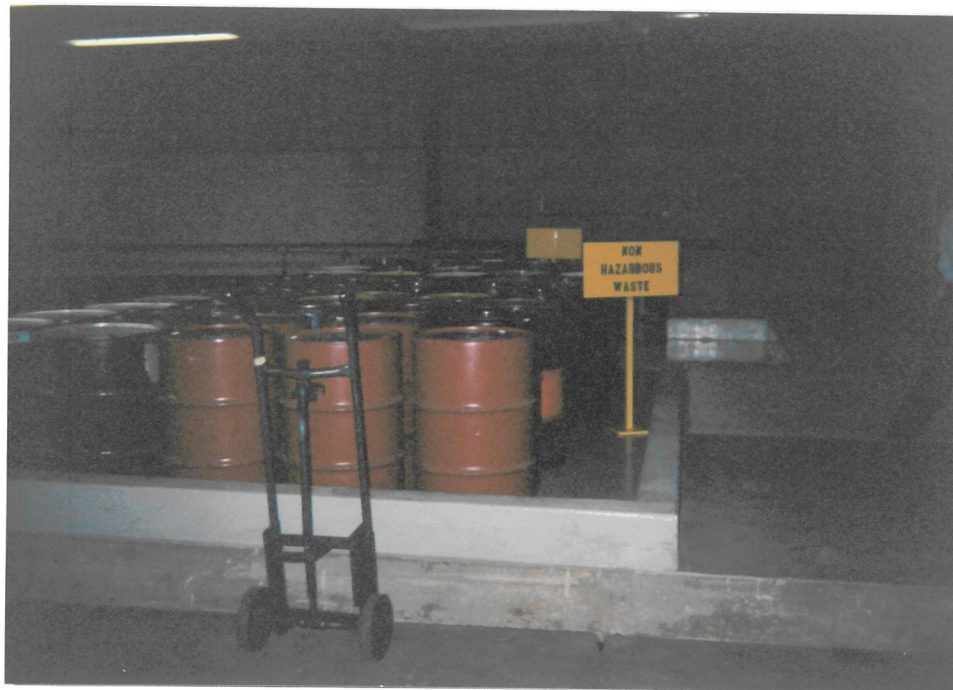
Photograph No. 5

Observations: The unit contained approximately 50 55-gallon steel drums during the VSI. The floor and concrete dike were in good condition with no visible cracks, pits, or stains (see Photograph No. 5).

Description: This photograph shows the Nonhazardous Waste Container Storage Area. This unit is located in the portion of the facility that is leased to American Pfauter by Pfauter Maag. American Pfauter also stores nonhazardous waste in this unit.

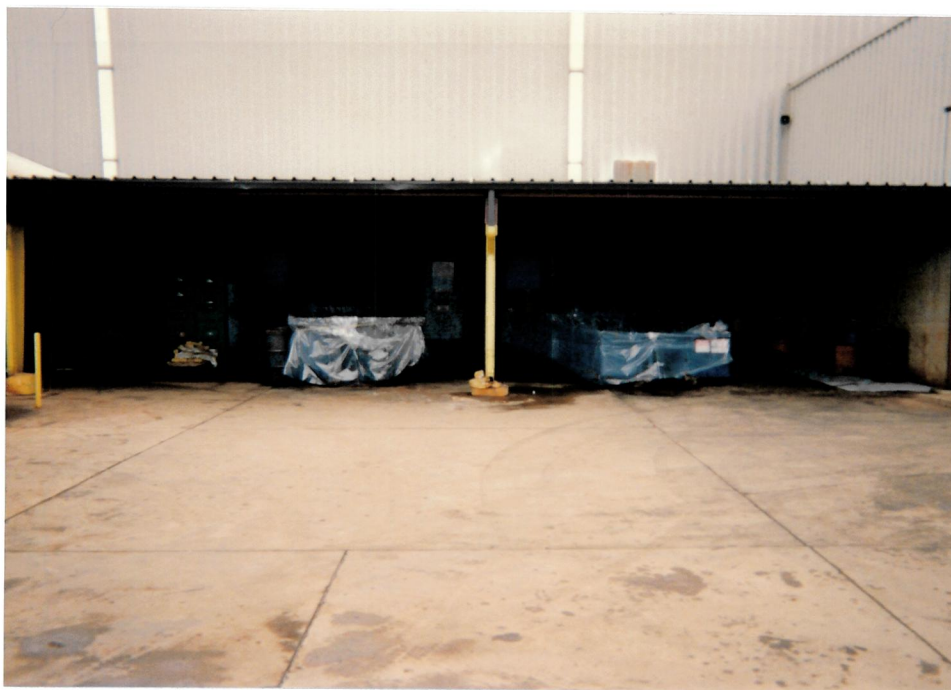
Photograph No. 6

Observations: Each dumpster was approximately half full during the VSI. There was no cracking or pitting of the concrete upon which the dumpsters were located (see Photograph No. 6).

Description: This photograph shows the Nonhazardous Waste Dumpsters used to store sludge and absorbent pigs.

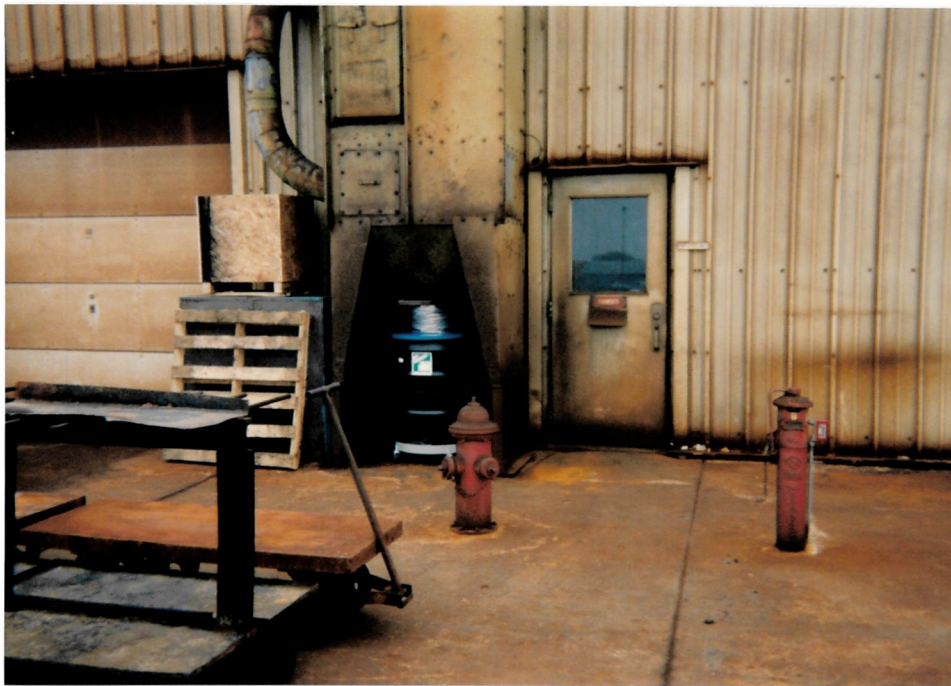
Photograph No. 7

Observations: During the VSI, the unit was collecting dust in a sealed 55-gallon steel drum. There was no evidence of odors or particulate escaping from the unit. There was no cracking, pitting, staining, or dust on the concrete beneath the unit (see Photograph No. 7).

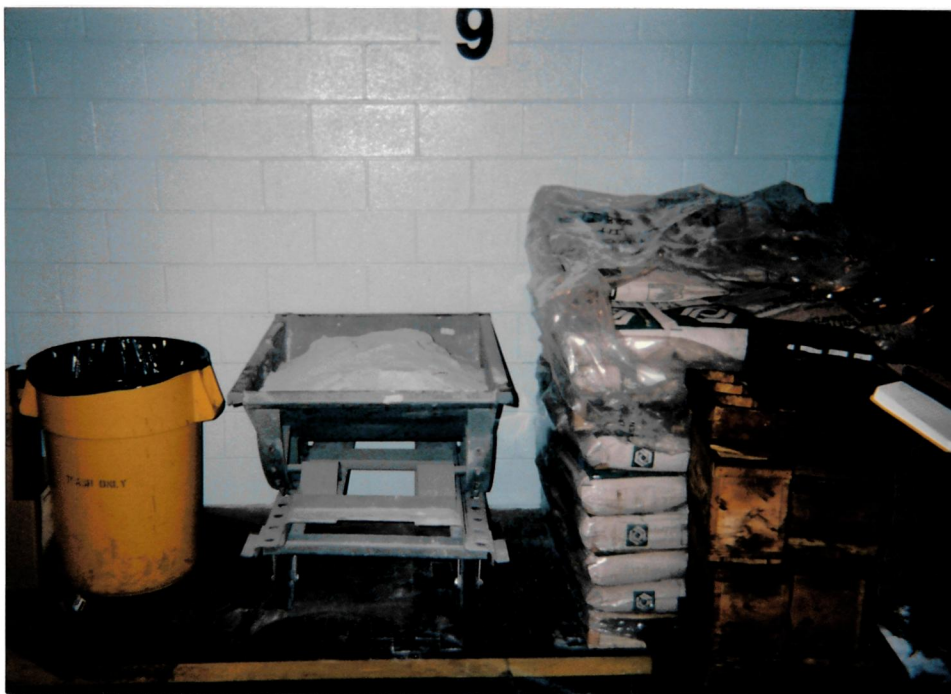
Photograph No. 8

The unit contained approximately 1 cubic yard of glass bead fines during the VSI. A small amount of glass bead fines was on the floor beneath the hopper (see Photograph No. 8).

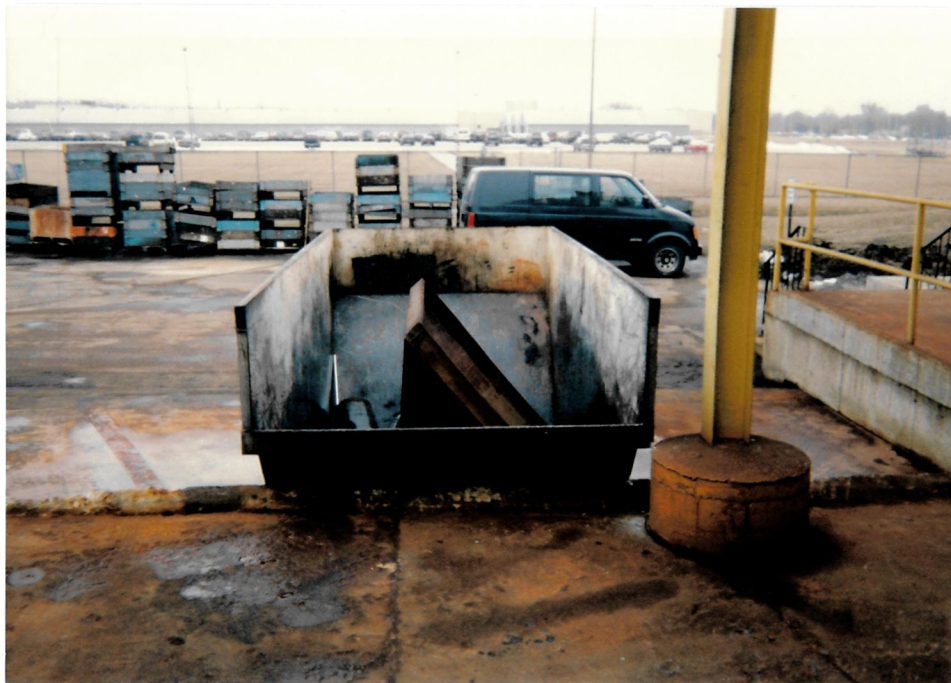
Photograph No. 9

Description: This photograph shows the 10-cubic-yard hopper used to store scrap metal.
